## RAILROAD ACCIDENT REPORT

FIRE ONBOARD AMTRAK PASSENGER TRAIN  
TRAIN NO. 11, COAST STARLIGHT  
GIBSON, CALIFORNIA  
JUNE 23, 1982

NTSB / RAR-83 / 03

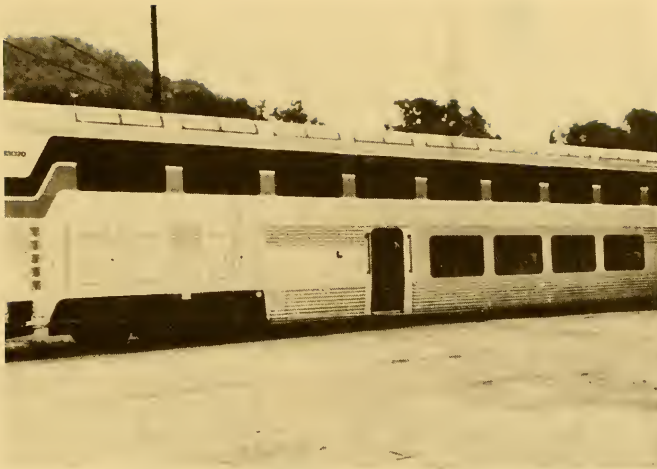
Figure 1.--Amtrak superliner sleeping car.

As the 1130 car attendant moved toward the 1131 car at the rear of the train, she met the rear brakeman coming forward through the end door of the car. She told him about the fire, and he radioed the conductor to stop the train saying, "We have a fire back here." Shortly afterward, the rear brakeman again radioed the conductor saying, "This fire is pretty big; we'd better stop." The rear brakeman continued toward the front of the 1130 car, knocking on doors and shouting, "Fire." The 1130 car attendant continued toward the rear of the 1130 car, exited through the car's upper level end doors, and proceeded down to the lower level of the 1131 car to awaken the 1131 car attendant, who was taking her rest period in bedroom No. 14. By that time, the train had been stopped, and the 1130 car attendant detrained from the right vestibule door of the car 1131. (See figure 1.)

When the 1130 car attendant and the rear brakeman became aware that a handicapped passenger was still in bedroom A on the upper level of the 1131 car, they climbed up the rear of the car to the upper level and attempted to enter the car through the upper level end door to rescue the passenger. The end car door, which was also the end of the train, had been locked with a key to prevent its opening by passengers. The rear brakeman could not open the door until he had been provided with a coach key. When the door was opened, volumes of thick black smoke immediately emptied through the door, thus, preventing their entry into the car. They discovered later that because the cars were oriented in the train such that the deluxe bedrooms were adjacent to each other, the handicapped passenger had to be reached from the front end of the car. (See figure 1.)

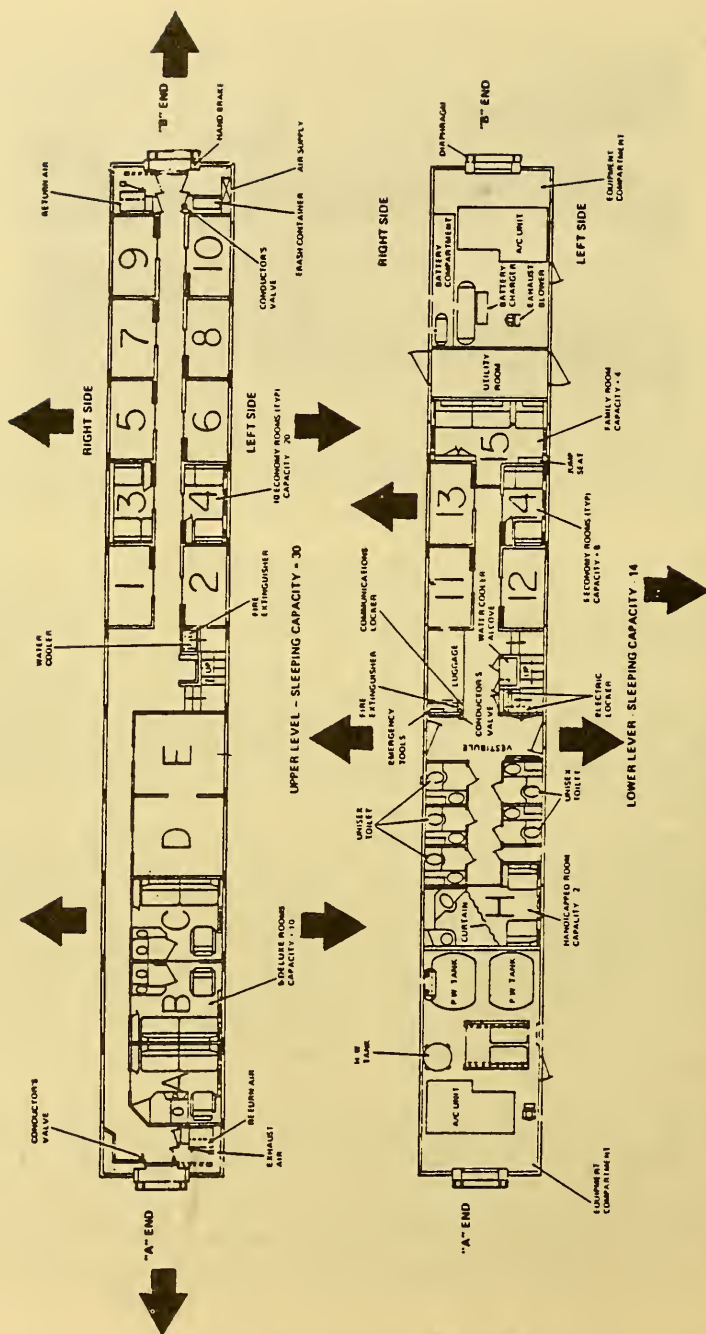
Figure 2.--Typical interior arrangement of the 1130 and 1131 sleeping cars.

Car Arrangement.--The superliner sleeping car consisted of economy (see figure 9) and deluxe bedrooms. The economy bedrooms were identified numerically and the deluxe bedrooms were identified alphabetically. (See figure 2.) Thirty passengers could be accommodated on the upper level of the car. A handicapped bedroom, equipped with appropriate facilities, a family bedroom, and four economy bedrooms were located on the lower level, which could accommodate 14 passengers. Five unisex restrooms for the economy bedroom passengers were also located on the lower level. The entrance to each bedroom was provided with a full-length curtain and a sliding door which contained a glass window and a door lock. The bedroom door could be locked only from the inside. To open a locked bedroom door from the outside, a phillips-type screwdriver must be used to remove screws holding a coverplate over the lock, and then a standard coach key can be inserted to unlock the door.

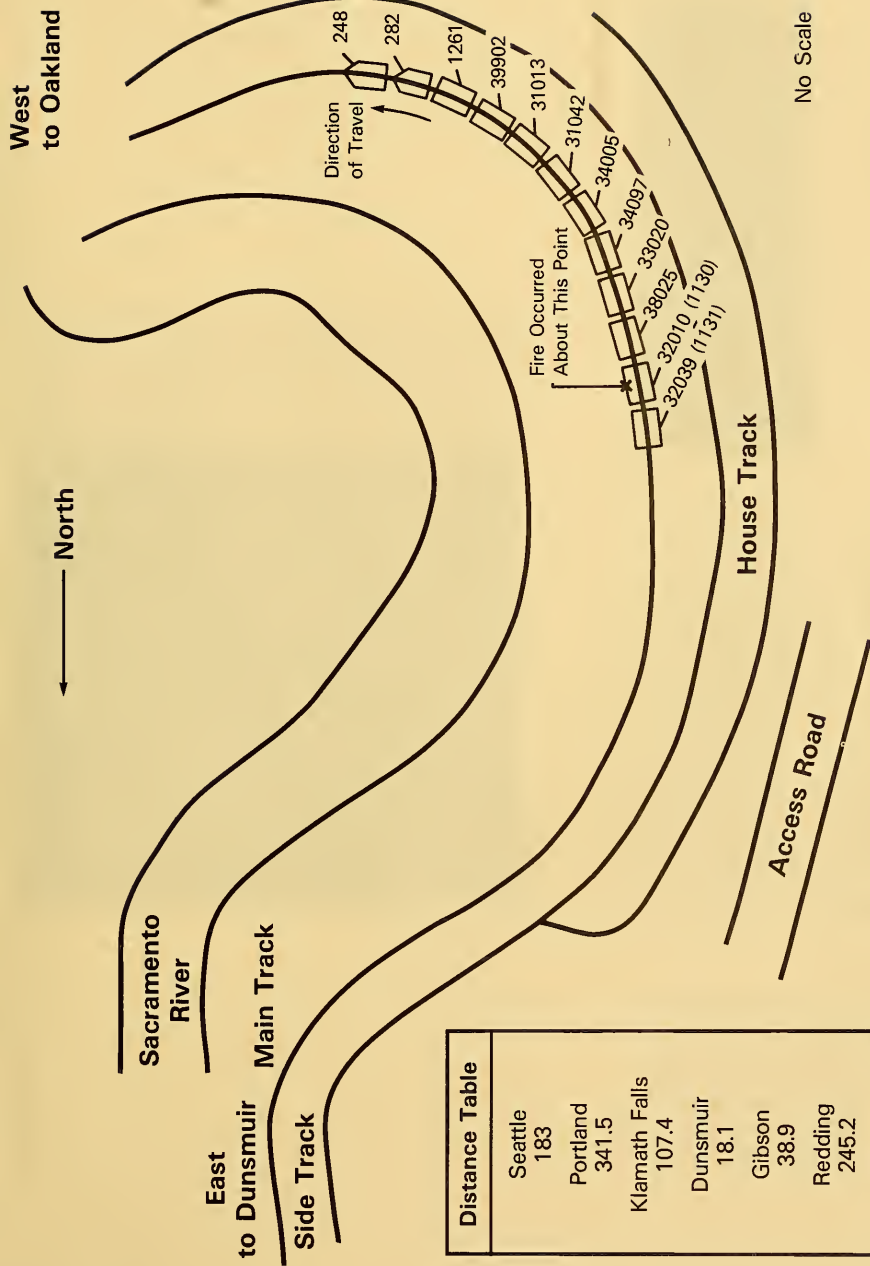
Figure 3.--Plan view of accident site.

The engineer said that he and the fireman looked northward at the train, which was standing in a left-hand curve in the direction of travel. (See figures 3 and 4.) They could see a yellowish light in the upper part of the 1130 car that was unlike the normal light reflected from a rail passenger car. When the engineer became aware of the magnitude of the fire, he radioed the dispatcher to send emergency fire assistance. Later, the conductor instructed him over the radio to make the moves required to separate the two rear cars in the train. The engineer said that he assigned the locomotive fireman the task of shutting off the electrical power to the train before the cars were uncoupled. The

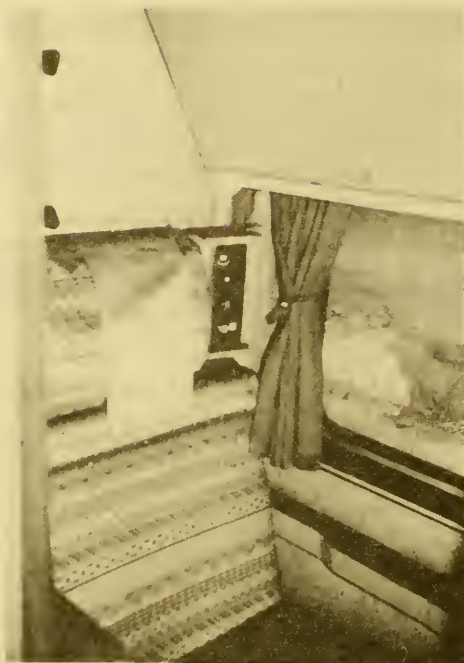
Figure 9.--Interior view of undamaged economy type bedroom.

The interior walls of the bedrooms, the ceilings, the floors, and the undersides of the upper berth were covered with Amtrak-approved nylon carpet. A neoprene backing pad was bonded to the carpet. Wool-nylon curtains or draperies were installed over the windows and doors. Melamine covered the partition between the bedroom and the hallways. (See appendix D.)
